January 5, 2018

Maclay Architects
Attn.: Kevin Dennis
4509 Main St.
Waitsfield, VT 05673
kevin@maclayarchitects.com

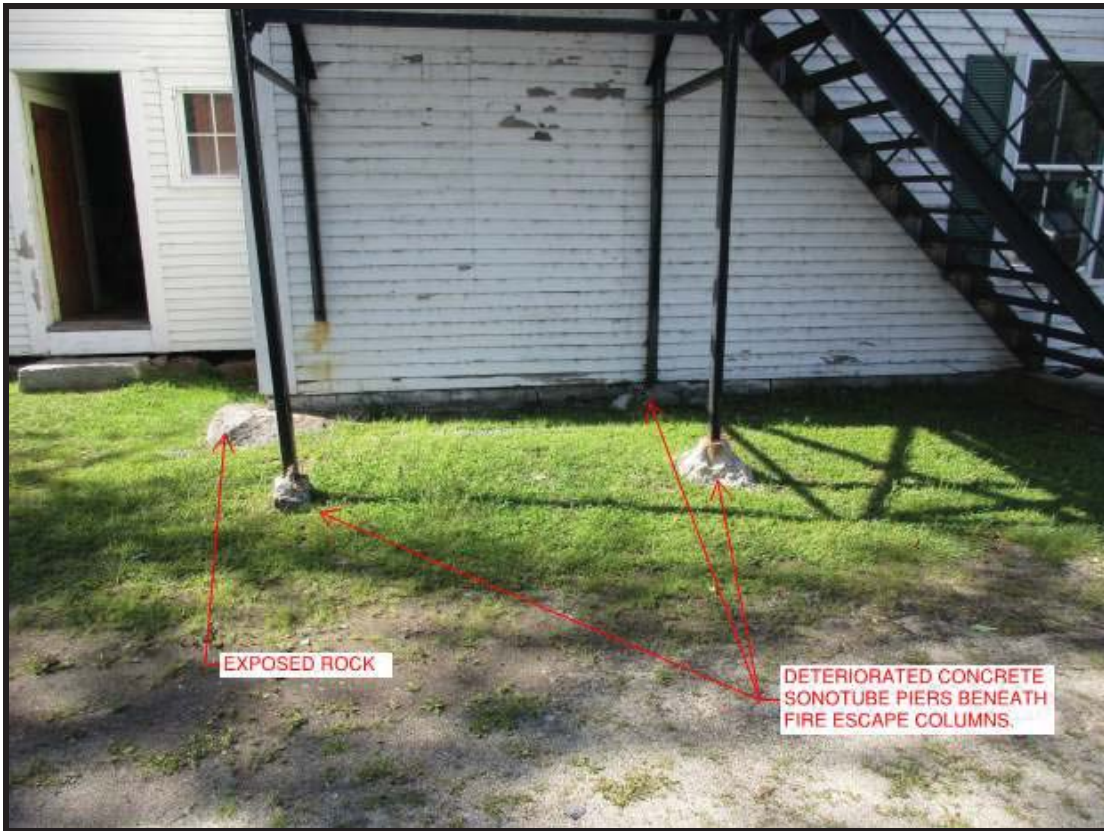
Figure 2 - Partial view of west exterior wall, depicting deteriorated concrete sonotube piers and exposed rock adjacent to the foundation.

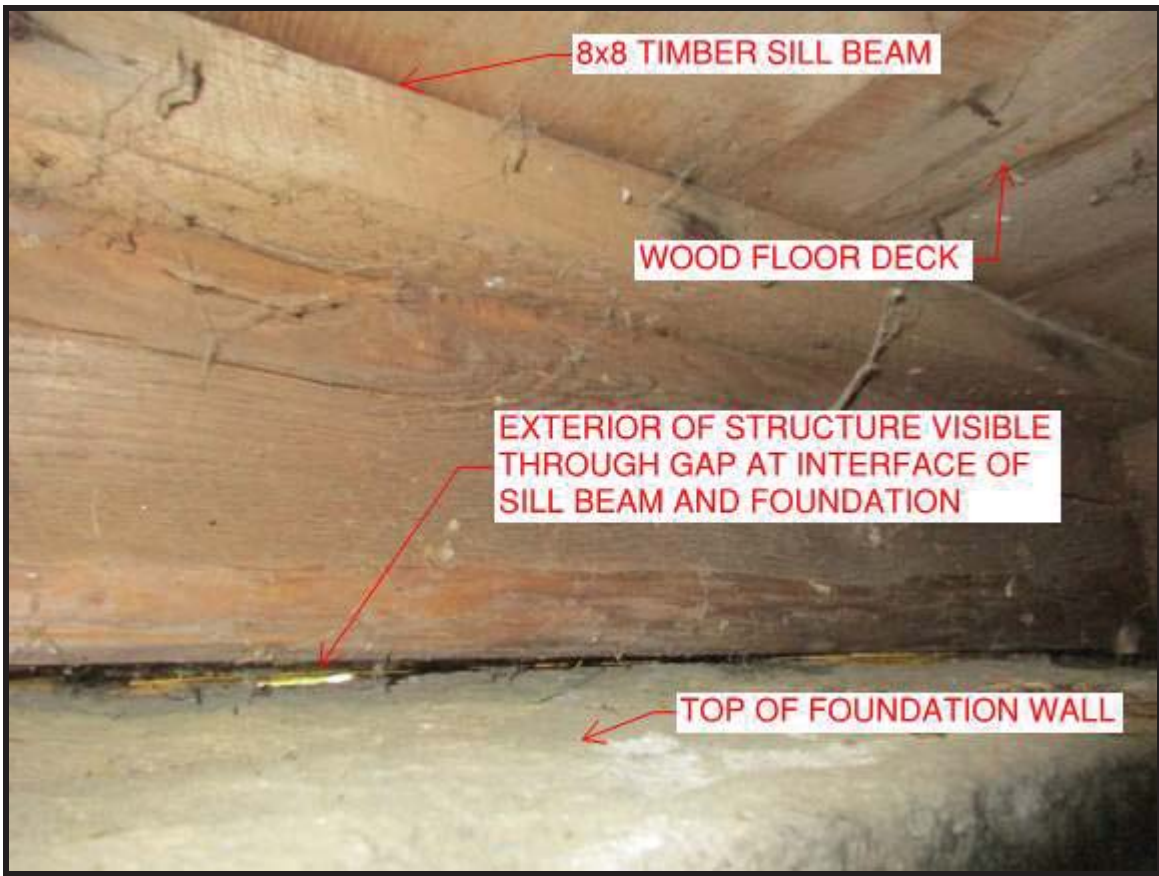
Figure 3 - Typical condition at interface of foundation and superstructure. Wood appeared to be in fair condition. Positive attachment of superstructure to foundation was not observed.

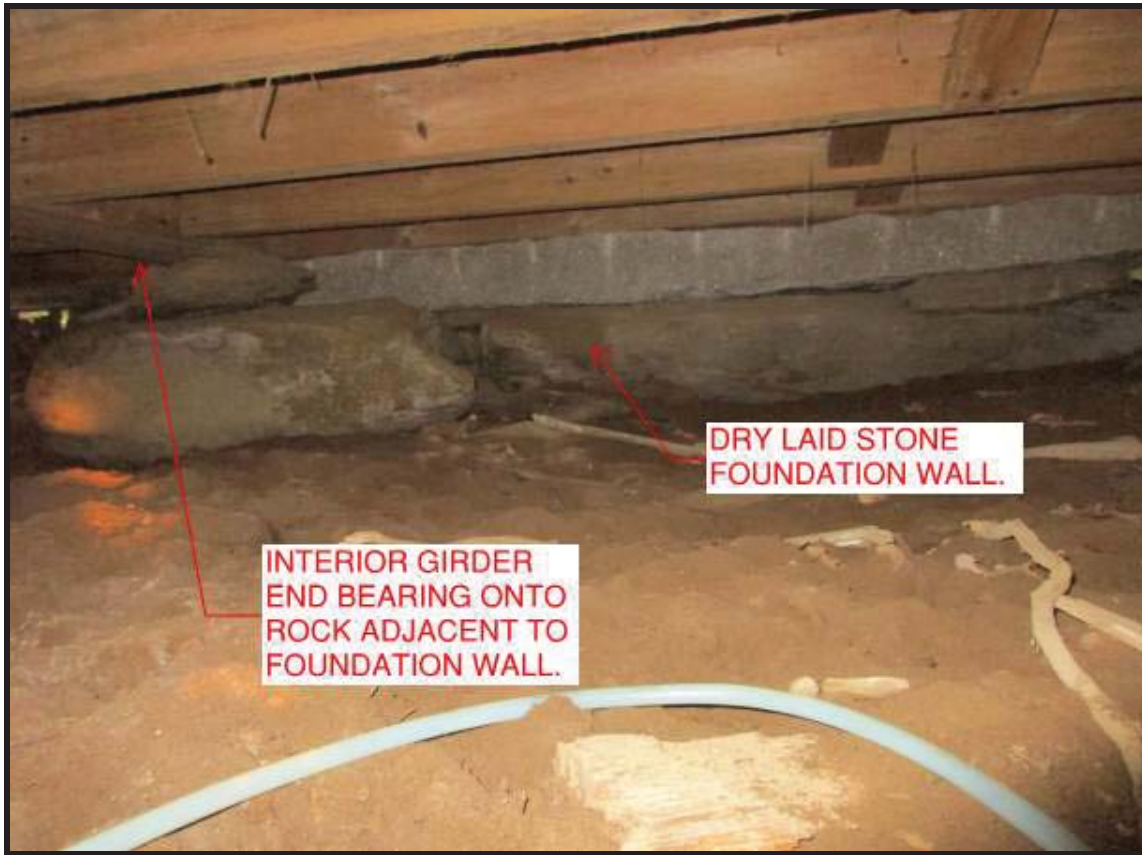
INTERIOR GIRDER
END BEARING ONTO
ROCK ADJACENT TO
FOUNDATION WALL.

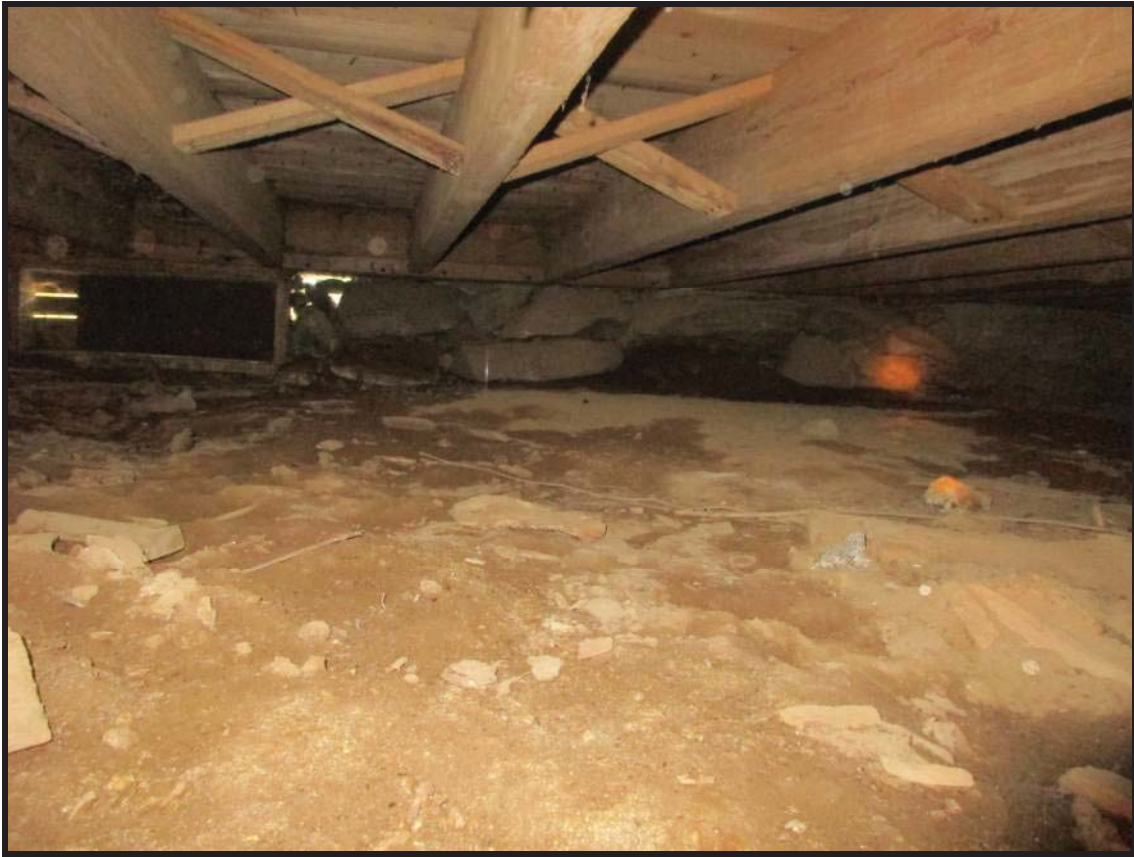
Figure 5 - View of first floor framing. Dirt floor with no vapor barrier was observed within the crawl space. Wood framing appeared to be in fair condition, with little to no rot/moisture damage observed.

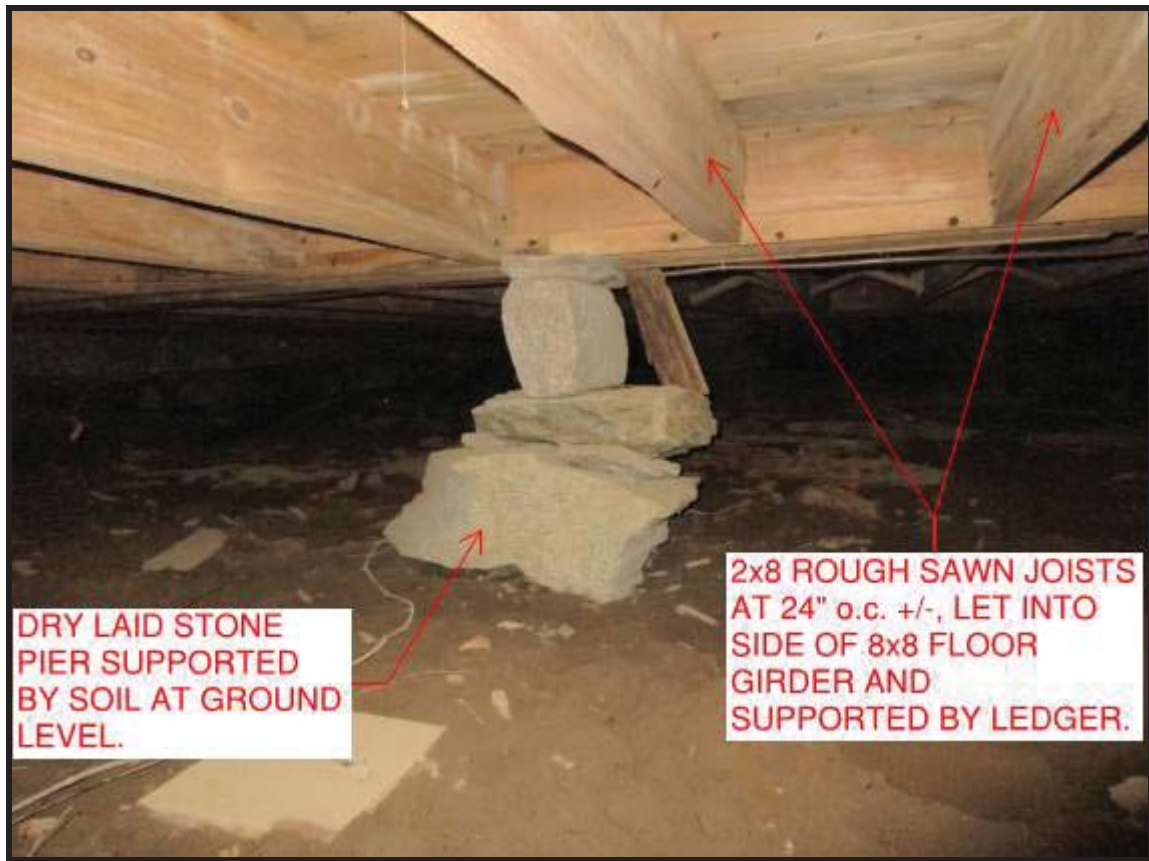
DRY LAID STONE
PIER SUPPORTED
BY SOIL AT GROUND
LEVEL.

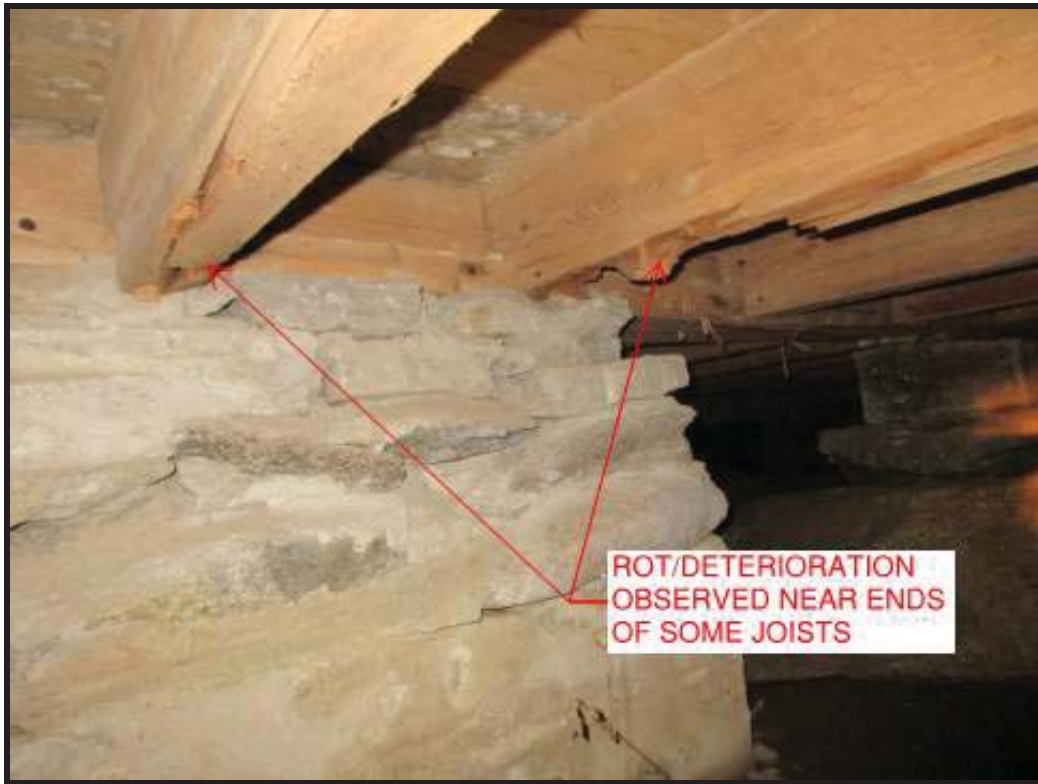
Figure 9 - Damage at ends of joists was observed in a few locations.
